**AERONAUTICAL ACCIDENT INVESTIGATION  
AND PREVENTION CENTER**

**FINAL REPORT  
A-00X/CENIPA/2008**

**ACFT REGISTRATION: PR-GTD and N600XL**

**MODELS: B-737 8EH and EMB-135 BJ LEGACY**

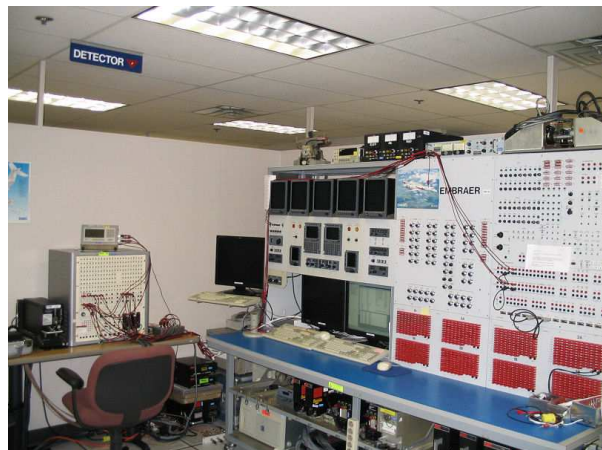
The second phase consisted in the execution of the procedure already validated, this time using the TCAS, RCZ and RMU units removed from the N600XL. This phase was successfully conducted, and the results did not indicate any unexpected behavior, or in discordance with the technical specifications, which could affect the adequate transmission of the Transponder signals. No change of the Transponder mode of operation was identified.

In addition, it was confirmed that the system being tested did not present the problem associated to the subject addressed by the AD 2005-0021 issued by EASA “*Transponder Reversion to Stand-By Mode*”, and by the AD 2006-19-04 issued by the FAA “*To prevent transponder of the Honeywell COM unit from going into standby mode*”. The members of the CIAA and other participants had the opportunity to randomly apply successive commands in the control panels, mainly in the RMUs, trying to create an unexpected abnormal behavior. Nothing abnormal in the functioning of the equipment was observed.

Figure 5. Integration bench for the Primus 1000

Figure 6. Integration bench - Primus 1000 and TCAS

Figure 7. Bench for the TCAS

Figure 8. Bench for the Primus II (Radio Navigation)

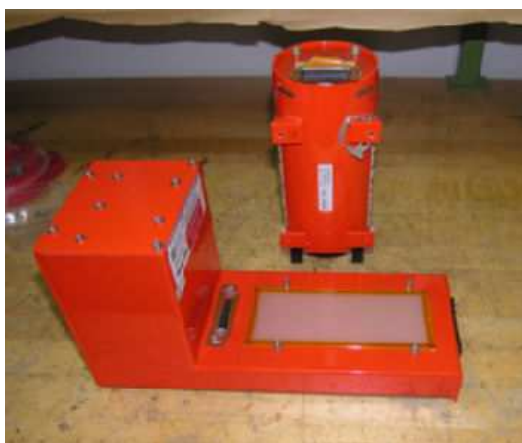
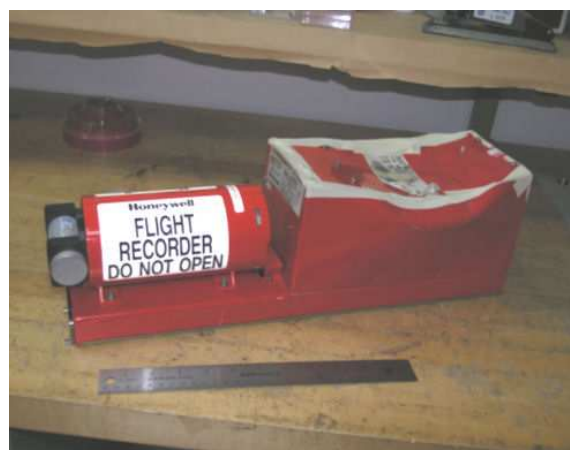
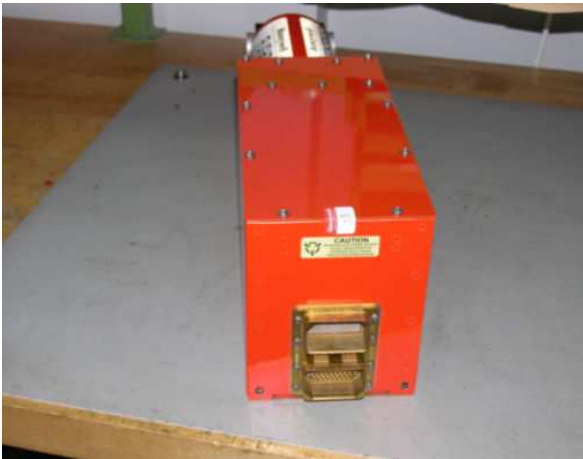
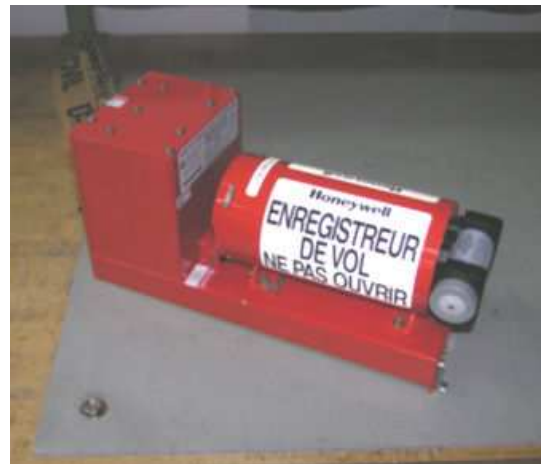
Figure 15: Complete base of an SSCVR unit

Figure 16: SSFDR unit, PR-GTD

**Figure 17:** SSFDR unit, N600XL

**Figure 18:** SSCVR unit, N600XL

The process of data readout was successfully performed on all 4 units.

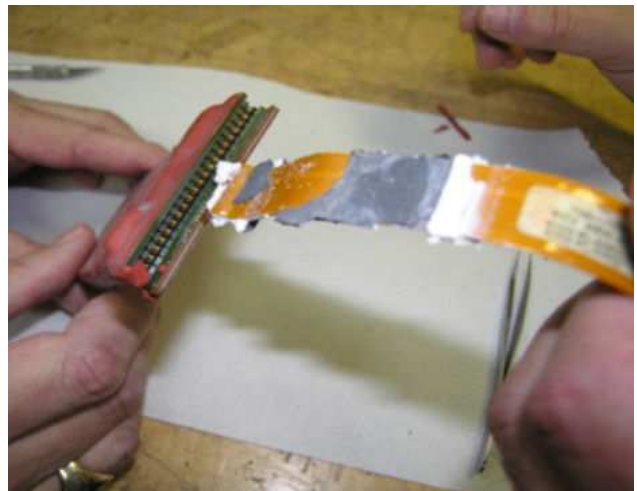
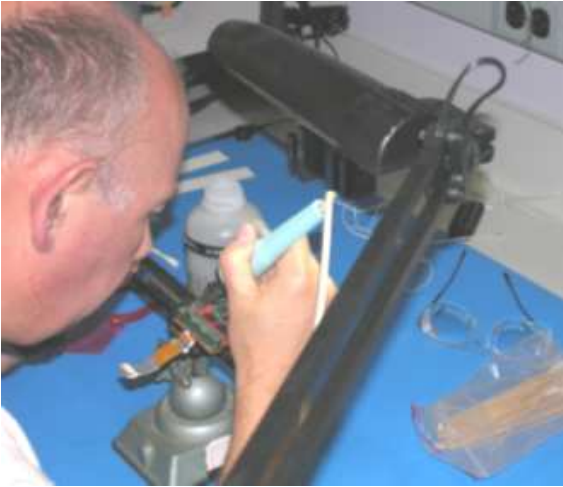
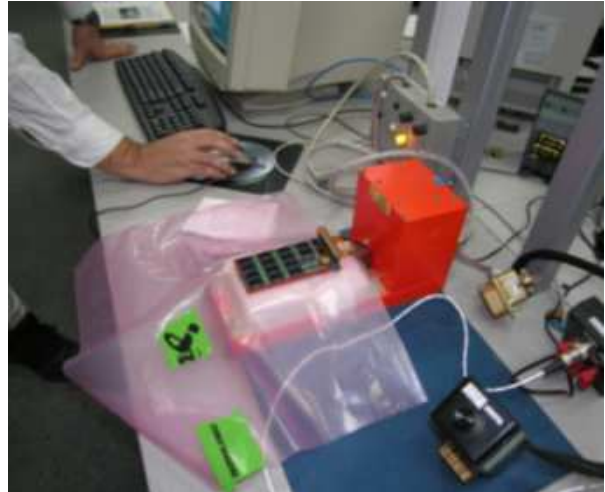
For the retrieval of the PR-GTD SSCVR cylinder data, the electronic board containing the memory chips was carefully removed from the cylinder (Figure 21), and the respective flat cable was recovered (Figures 22 and 23).

The electronic board was then installed in a complete SSCVR unit (Figure 24). Similarly, the protected cylinder of the PR-GTD SSFDR was removed and subsequently installed in a complete SSFDR unit.

Figure 21: Removal of the memory, PR-GTD SSCVR

Figure 22: Memory board and flat cable, PR-GTD SSCVR

Figure 23: Flat cable recovery, PR-GTD SSCVR

Figure 24: Memory board reading, PR-GTD SSCVR

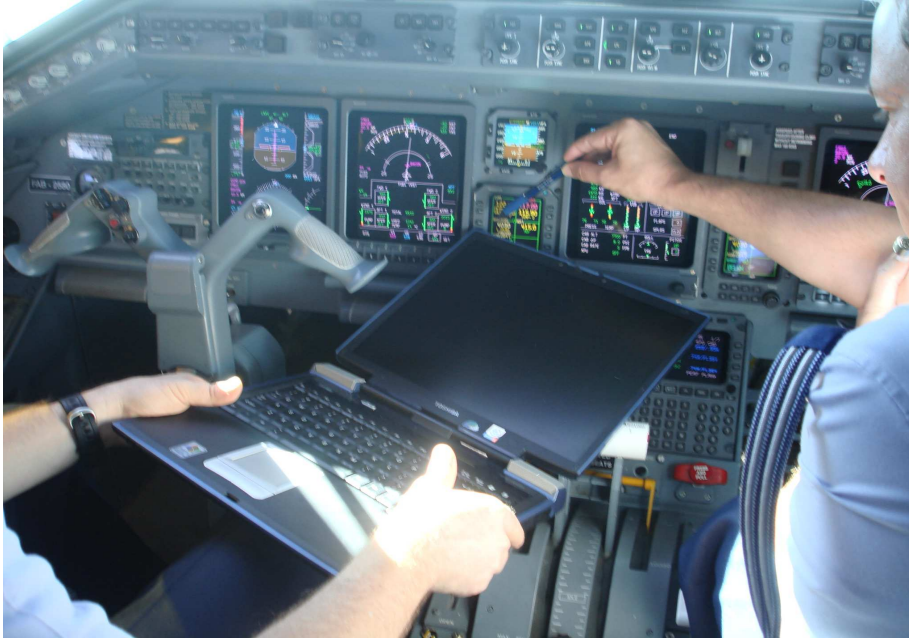
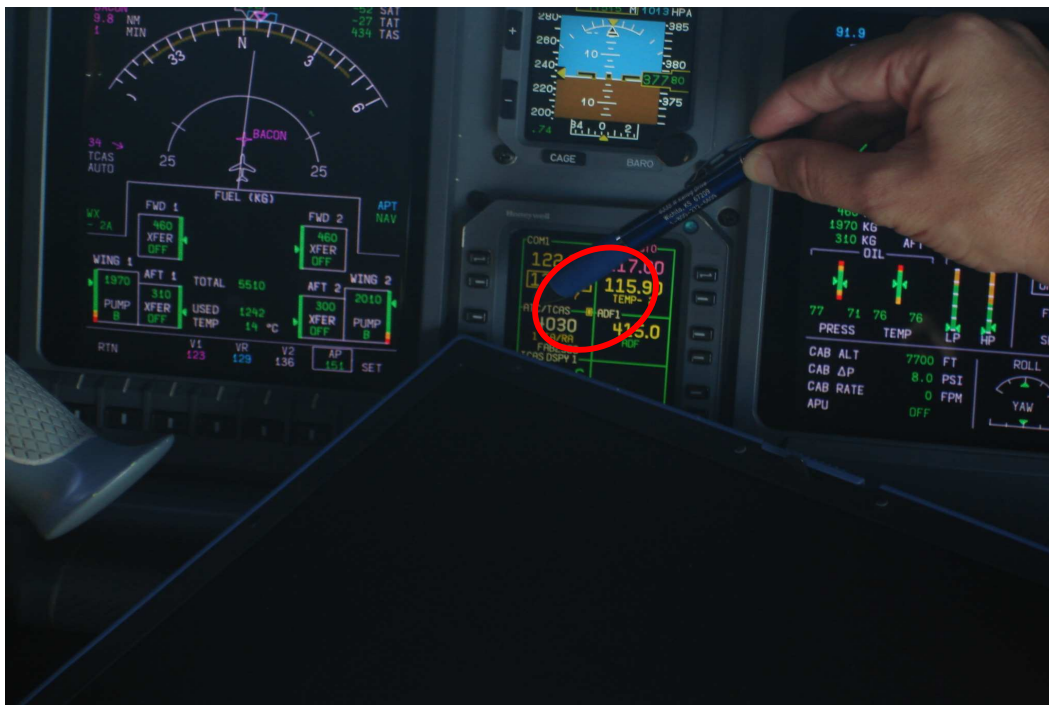
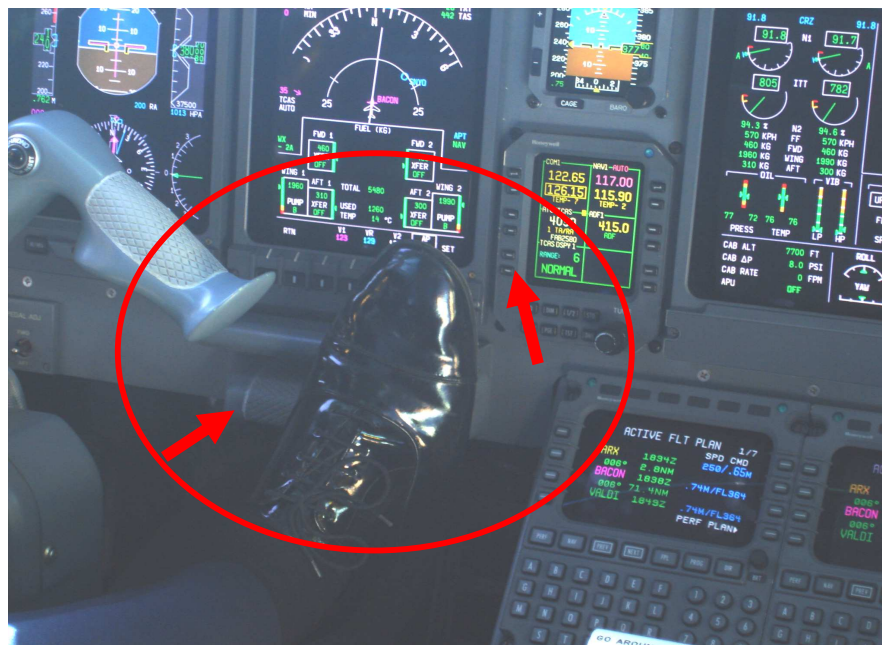
- By handling the *laptop* with the screen open at a pronounced angle (close to horizontal), it is possible to hit the command Button of the Transponder. However, this unintentional action can be easily noticed, as the signals can be monitored visually. On the other hand, one has to consider that it is not logical to operate the *laptop* in such a position;
- All the time, it was possible to observe the indications of the transponder on the various displays, both for the SIC and the PIC. The use of the *laptop* is not capable of interfering in the sighting of the aircraft panel by both pilots at the same time.

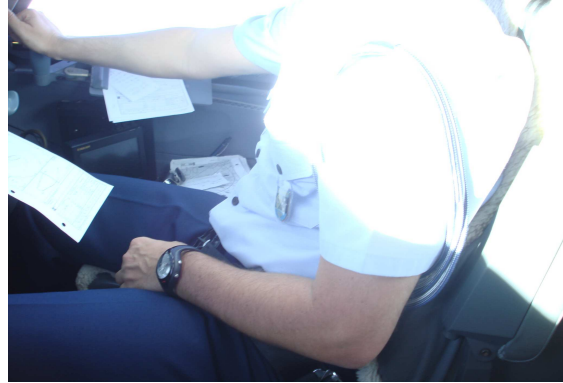
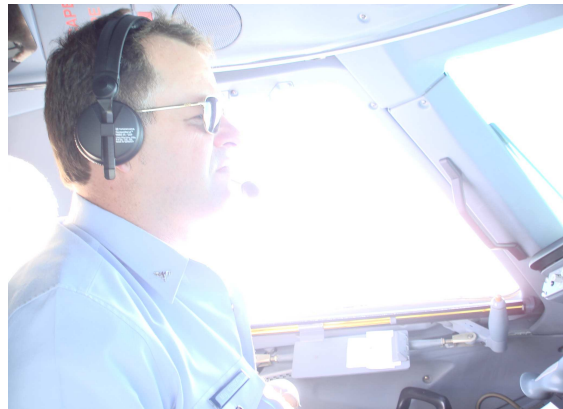
- It is possible to observe that the sunshine touches the SIC on the chest, in a area that is tangent to the chin is above the abdomen (Figures 41 and 42);
- The SIC reported a sensation of discomfort due to the intense heat on his chest;
- As the sunshine touches the SIC below his chin, his eyes end up being protected by the overhead panel, allowing a perfect visualization of the instruments, as they are not directly hit by the sunlight (Figures 38 and 39);
- Since the frontal panel of the PIC is also protected from the sunshine, it is possible for the SIC to visualize it normally (despite the parallax), in the same way he visualizes his own panel;
- For the PIC the conditions were similar, and, even with the sunlight coming from the left, the visualization of the instrument panel was not hindered (Figure 44). There is evidence of the use of the sunshade by the crew.

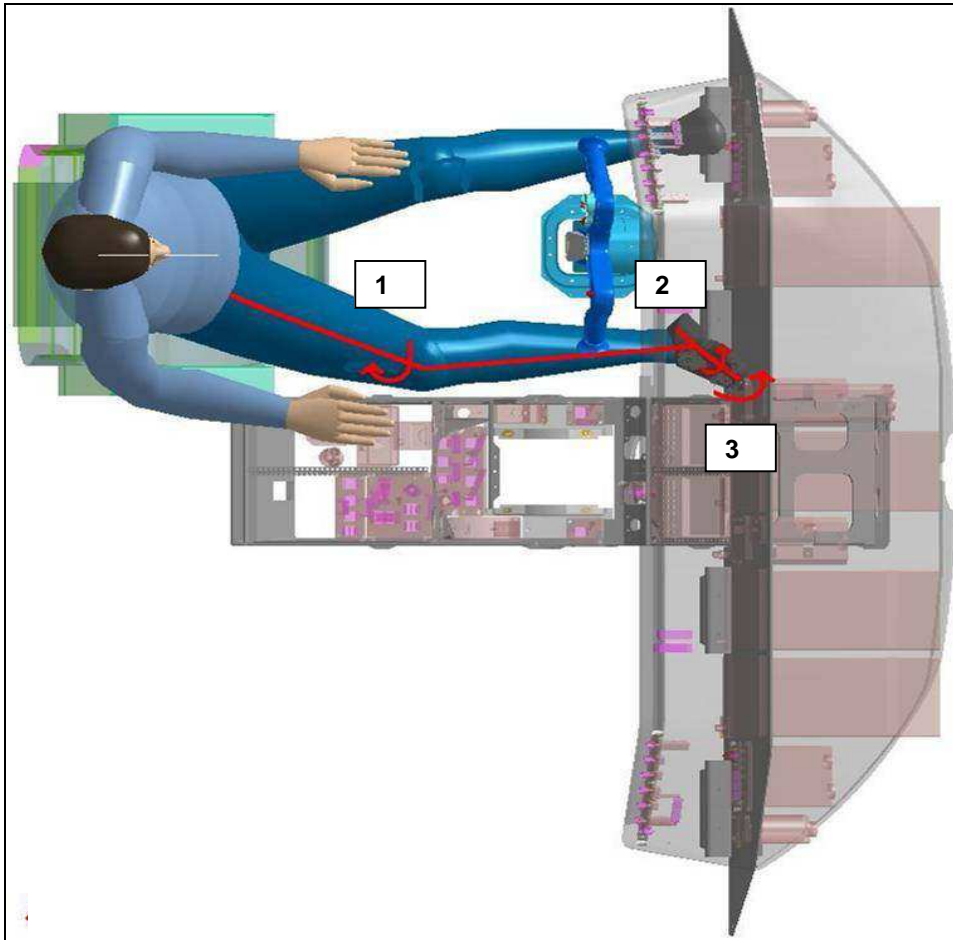
Figure 48

Additionally, the following picture shows the movements the PIC should perform so as to get his foot reaching the RMU1:

- (1) – Thigh lateral rotation
- (2) – Foot Inversion
- (3) – Plantar flexion.

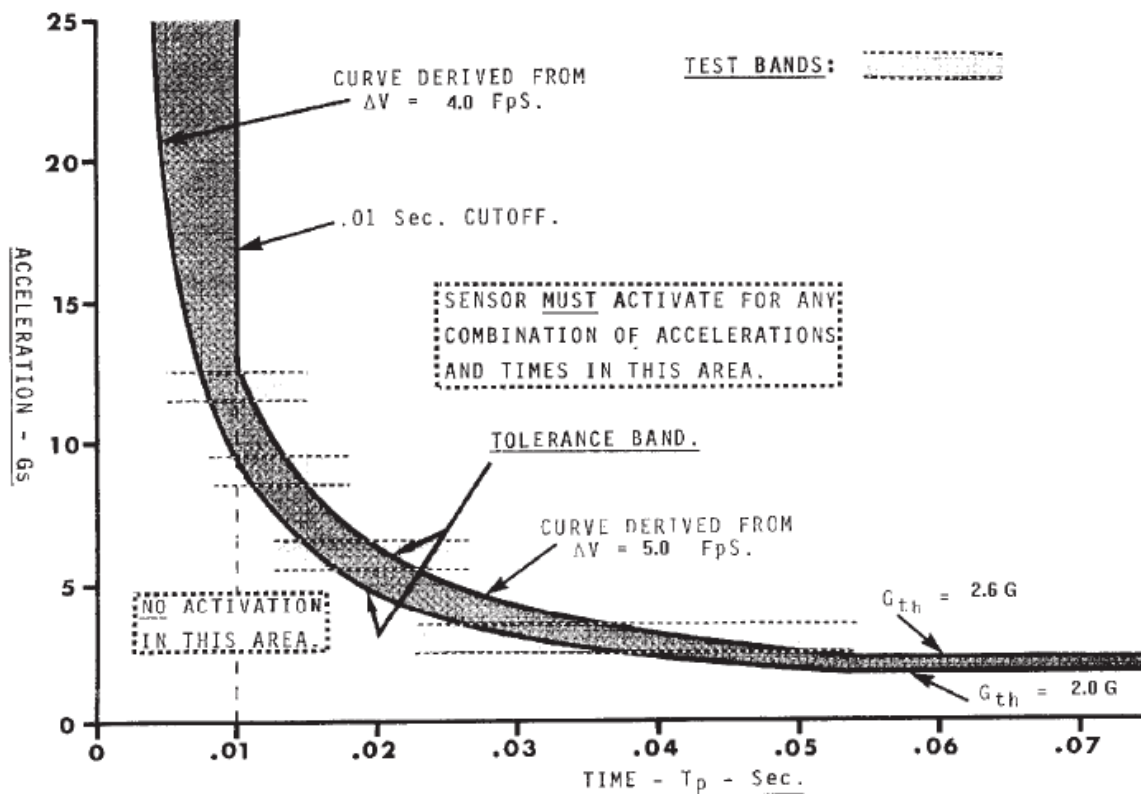
Figure 53

The crash force activation sensor or G-Switch is designed to activate according to the plot time versus longitudinal G force as shown by the Figure 1. For short impact the G force to activate the ELT is much higher than a relatively long impact.

After the N600XL and PR-GTD collision, no signal from the PR-GTD ELT was received by COSPAS/SARSAT system to help the search and rescue effort. While the PR-GTD was already in a spiral dive and before it suffered the in-flight breakup, the recorded FDR information revealed that the longitudinal acceleration did not exceed 0.5 G. This value was not sufficient to activate the ELT, according to figure 1.

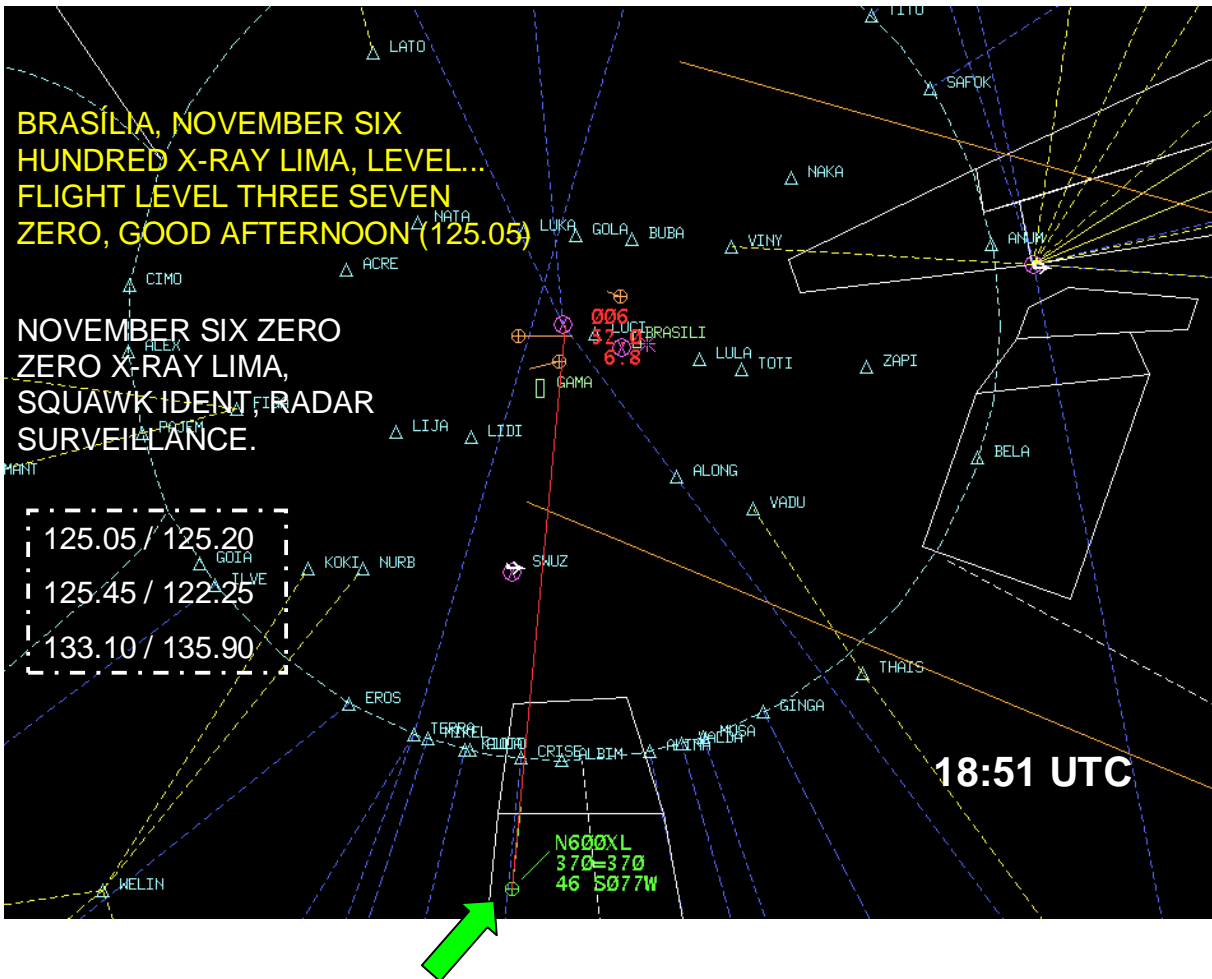
**Figure 55**

Figure 55 above depicts a view of the data block at the moment of the last two-way radio contact with Brasilia Center, sector 5, on the frequency 125.05 MHz.

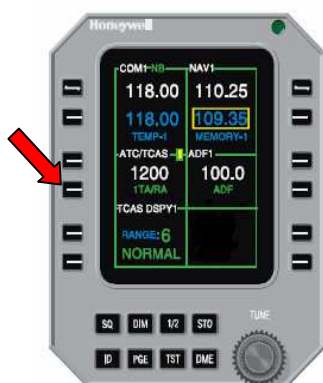
**Figure 58**

According to the information available, the loss of the Transponder signal on the screen of the air traffic controller occurred around 19:02 UTC, indicating that the STANDBY feature of the transponder had probably been selected.

For the Standby mode to be selected, it is necessary to press the fourth top to bottom left button, in one of the RMUs (it has to be pressed twice in a 20-second interval).

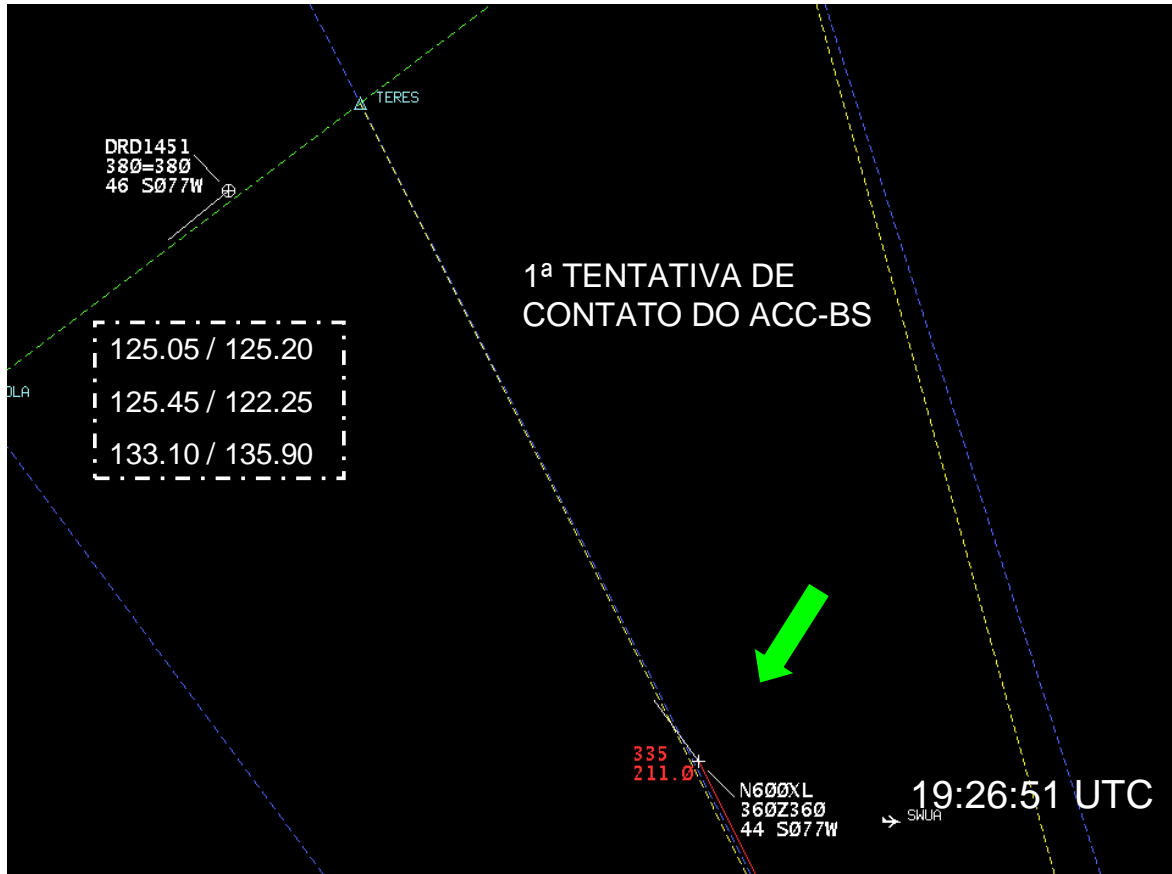
**Figure 60**

Despite being transmitting on 125.05 MHz, the first call was only made when the aircraft was already at **211 NM away from BRS VOR.**

The aircraft icon still showed a correlation between the primary radar and the 3D radar returns.

The effective range of the frequency 125.05 MHz at FL 300 is 300 NM. Although the aircraft was within the frequency theoretical maximum range, the positioning of the aerials is for sector 09.

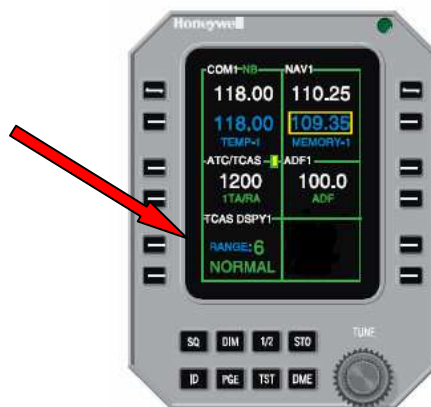
Figure 66

in the RMU, mainly due to the fact that the field that indicates the operation mode of the transponder in the RMU is located just below the field "COM".

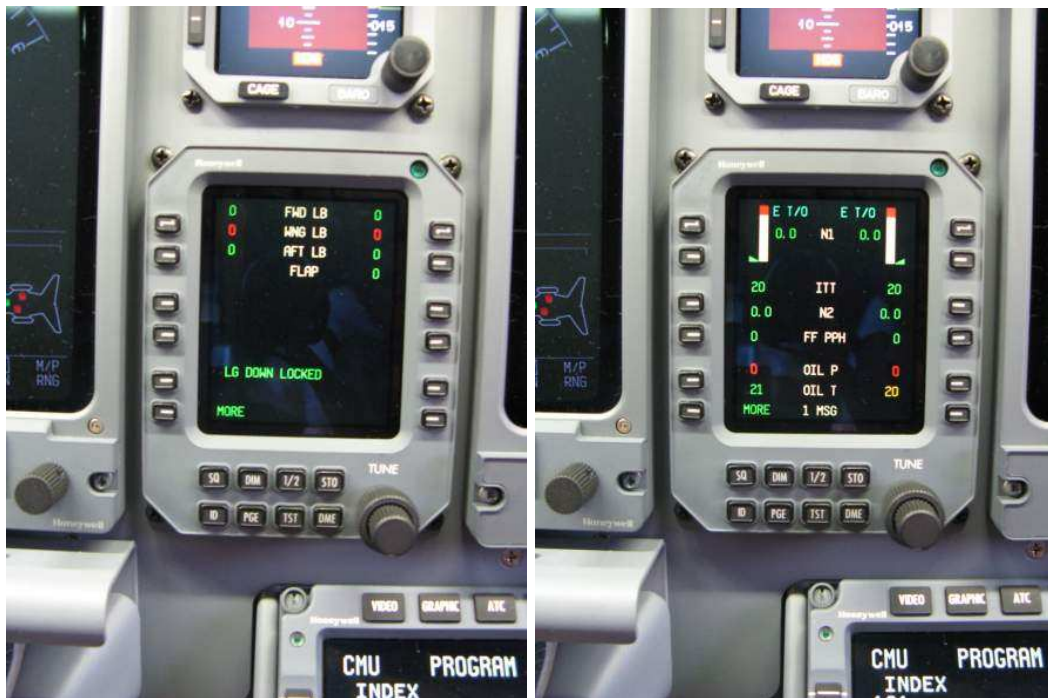
The RMU is used primarily for adjusting the navigation and communication frequencies. It also functions as a backup for the EICAS; therefore, pages of the RMU can be accessed to check the fuel status, engine parameters, flap position, TCAS, etc., as shown in the Figures below.

Therefore, it is possible that, while handling the pages of the RMU, the captain unintentionally set the Transponder to STANDBY, by pressing the RMU button twice in less than 20 seconds, without being aware of his action.

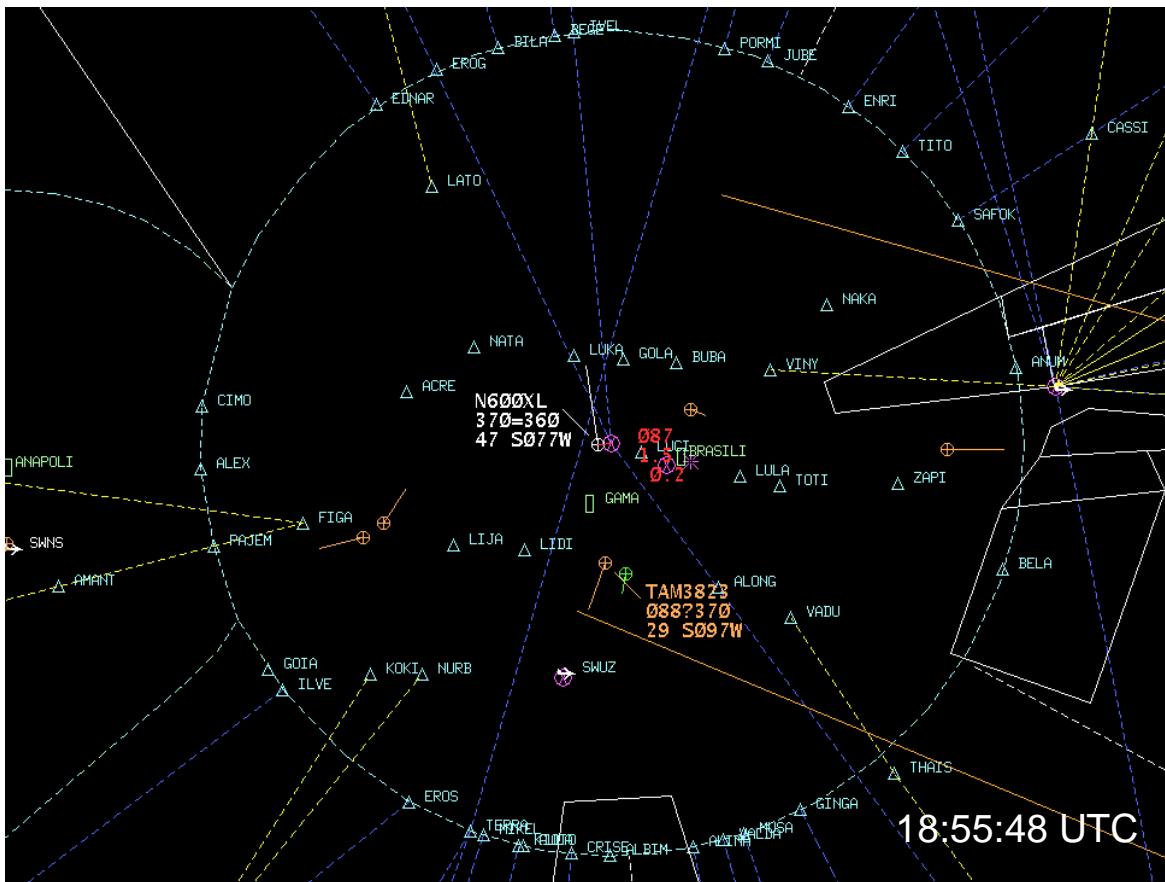
Figure 72 – RADAR presentation of the STVD at CINDACTA I

After the vertical of BRS VOR, the data block pertaining to N600XL started to show, as specified, the information 370=360, warning the controller that the aircraft was at flight level 370, while the level authorized for that segment was FL 360 (See Figure 70).
